## Five Die in Danbury, Connecticut, Federal Correctional Institution Fire

This report is based on an investigation conducted by the NFPA Fire Investigations Department. The assistance of the Federal Bureau of Prisons, especially Norman Carlson, Director, and Fire Marshal Fred Tomaino of the Danbury Fire Department is appreciated.

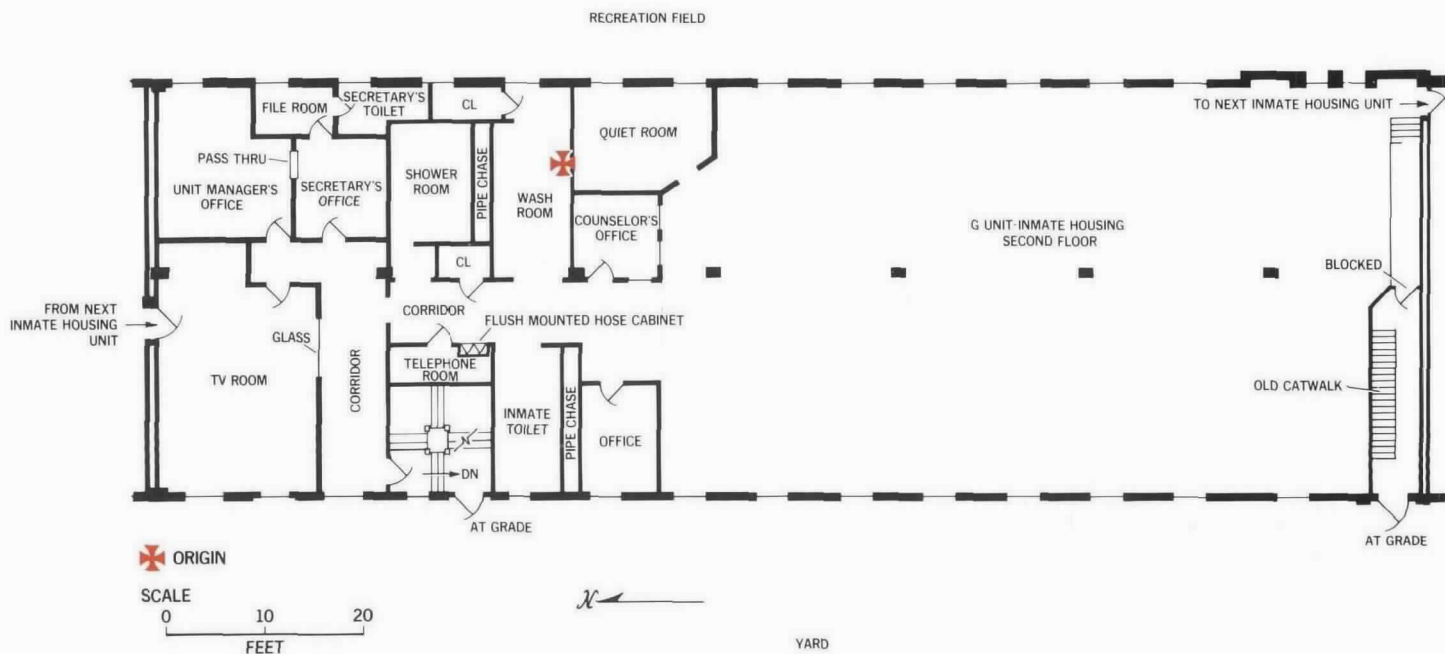
Figure 1.

The primary means of egress from G unit was at the north end of the dormitory, into a corridor and down a stairwell to ground level. A secondary horizontal exit opened into the next inmate housing unit to the south. There was a third way out of G unit. This was part of an old catwalk arrangement; however, the door leading into the narrow stairwell was blocked for security reasons. Also, there was no floor at the base of the catwalk because of excavation being done to replace steam pipes.

After the two primary means of egress from G unit became unusable, one due to the fire and the other due to a broken key in the lock, correctional officers and inmates went up an old catwalk stairwell (see Figure 1) to remove plywood and two-by-four braces that held the wooden door at the top of the stairwell closed.

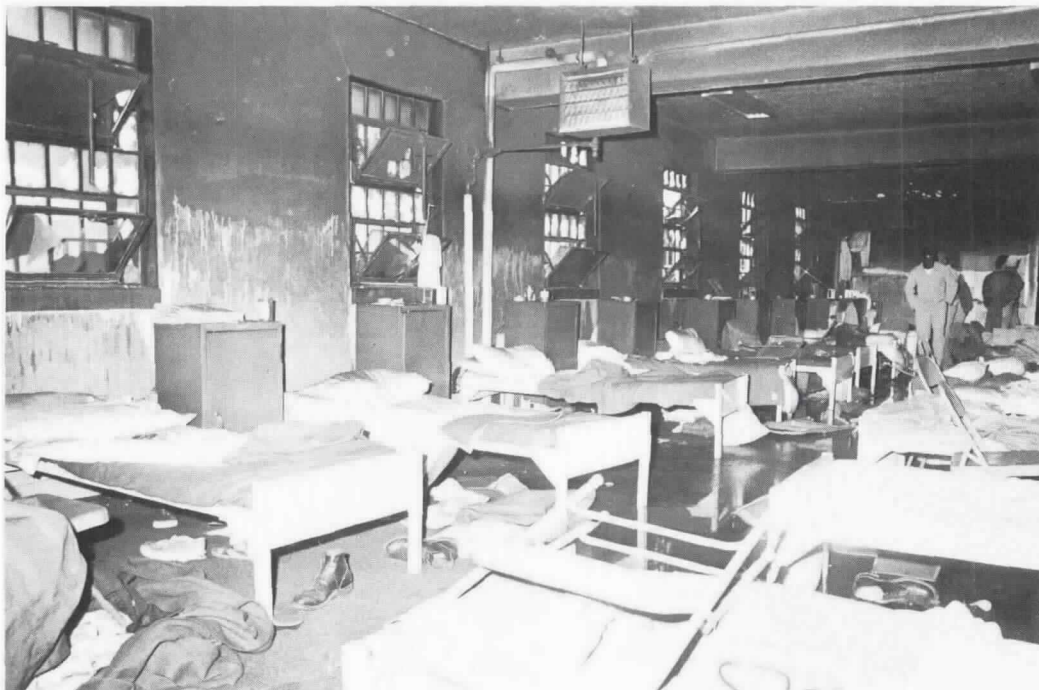
Interior view of Inmate Housing Unit G at FCI-Danbury.

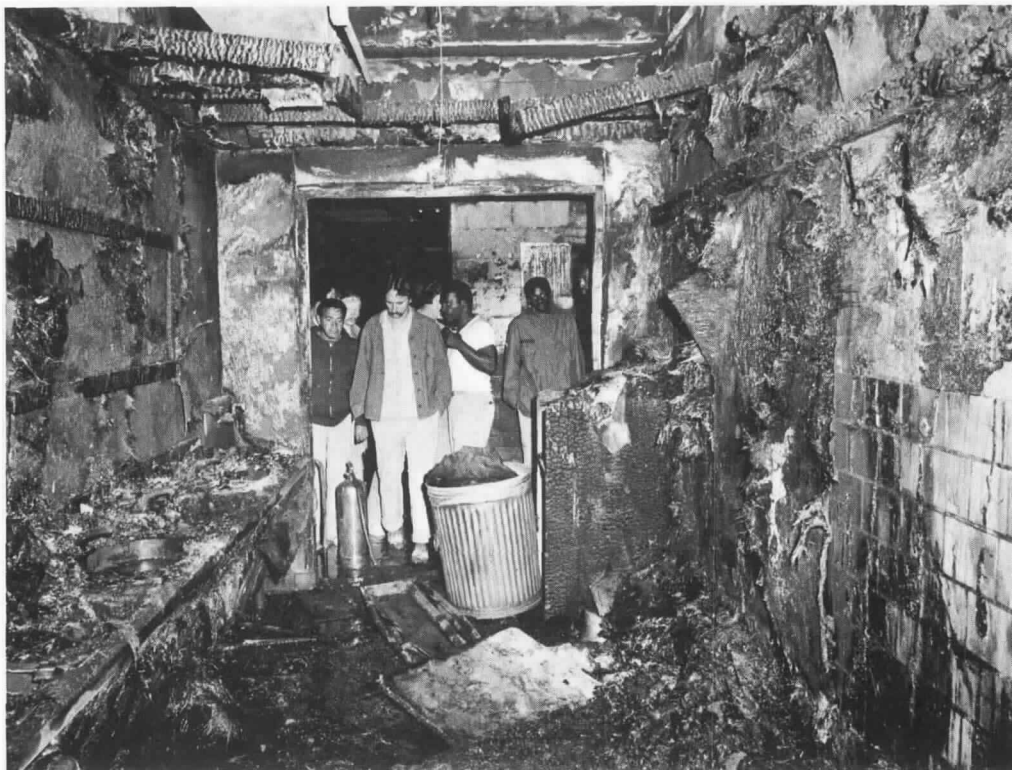
Heavy black smoke began to be generated by the fire as the plastic paneling on the walls and ceiling of the washroom became involved. The correctional supervisor could not use the standpipe hose because the cabinet was locked and his keys were outside with the yard officer. When the ceiling system began to collapse, it became evident that the fire could not be easily extinguished and that exiting past the washroom area was becoming impossible. The correctional supervisor left the area with six or seven inmates and went back down the stairway to the exterior. The yard officer locked the door after these inmates and the correctional supervisor had exited.

Washroom of G Unit at the Federal Correctional Institution in Danbury, Connecticut. Area of fire origin is at the left.

The fire began in clothing hanging on wooden pegs on the southern wall of the washroom. It was determined to be of human cause, but whether the fire was accidental or incendiary is still being reviewed by the Connecticut State Fire Marshal's office, the Federal Bureau of Prisons, and the Federal Bureau of Investigation. The fire spread to the adjacent corridor and counselor's office, consuming fiberglass-reinforced plastic wall paneling, plywood, high-density compressed particleboard, and thin plywood paneling. There was no fire extension into the dormitory area and no structural damage.
